Trees on bridges and buildings and the damage they cause

Bridge collapse

On 2nd August 2016, a bridge on the Savitri river in Konkan region of Maharashtra, near Mahad, collapsed.

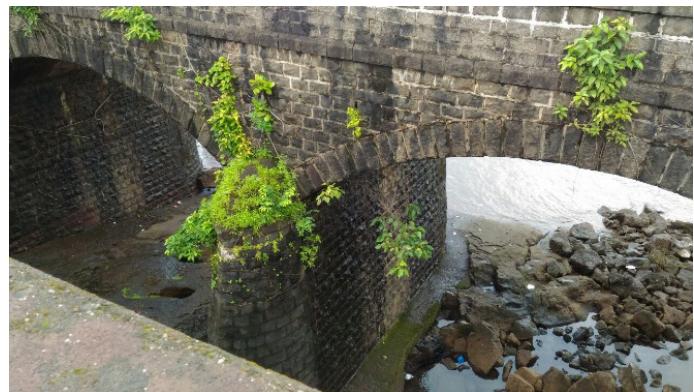
Heavy rain, not human error led to Mahad crash: IIT report

Mumbai: The report commissioned by the Maharashtra government to zero in on the cause of the Mahad bridge collapse has concluded that excessive rainfall led to the tragedy, not human error.

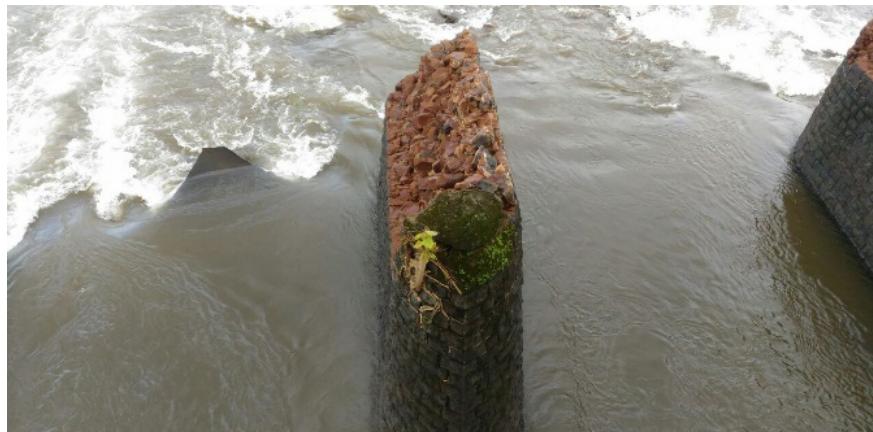
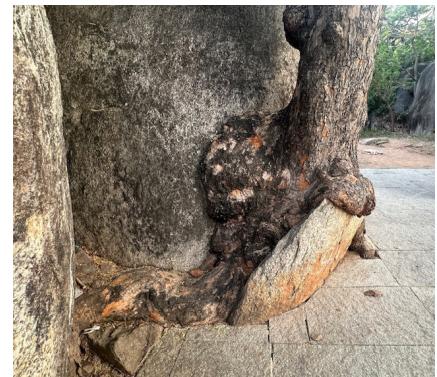
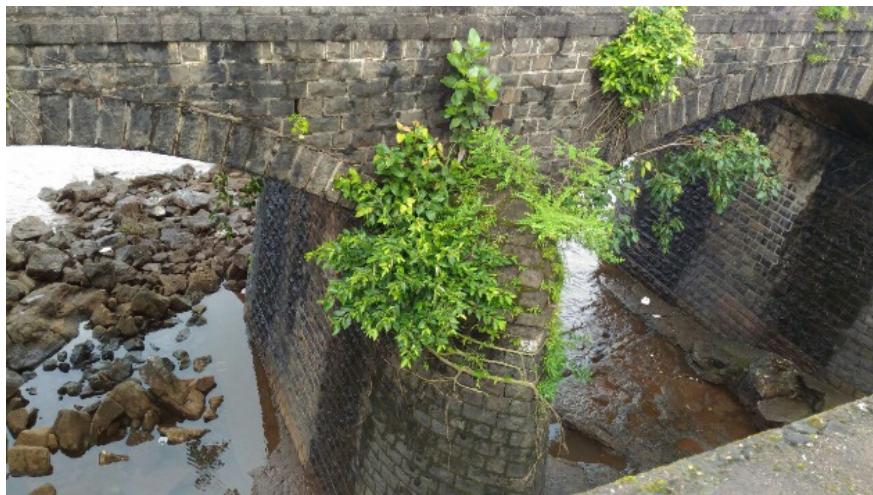
The bridges constructed in India in colonial times had stone arches in

which each stone was carefully crafted at a specific angle and finally rested by a keystone. Since the cement and concrete industry was not well developed, the space was filled with ordinary rub-

ble, often without a binder. These details can be seen in the remains of the Savitri bridge. The fine gaps are often nested by birds, and seeds of fruit-bearing trees (like banyan), which weigh less than a milligram, entered these gaps via bird droppings.

If the vegetative growth are not removed early, they can be dangerous for the structure. The problem with new bridges may not be so serious (though we can find trees growing on even new structures) because these are cast in concrete. The portion that is filled with clay is reparable in the case of serious defects arising because this part is fully supported. The span is all concrete, is not porous and does not suffer the risk of collapse.

There are thousands of bridges of the British era still in use in India. These can continue to provide useful service if proper maintenance is done. One of the most important aspects of maintenance is prevention of vegetative growth within them.

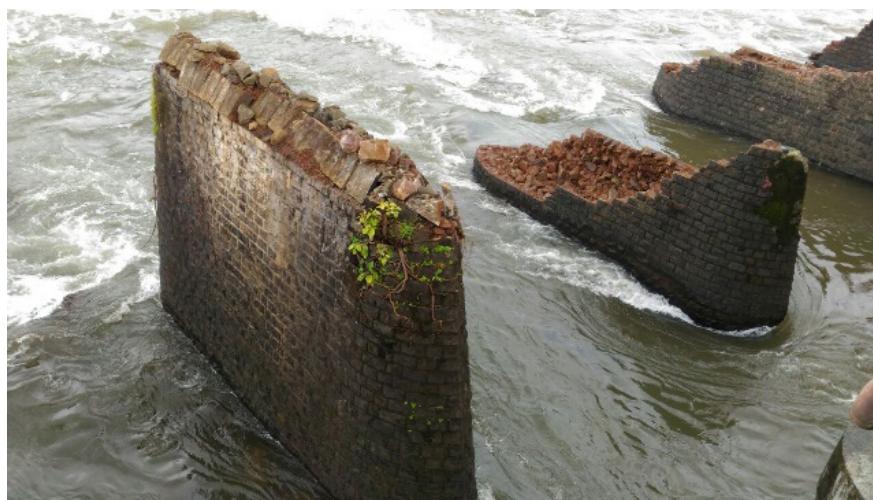
Roots of trees are very strong. They grow slowly, but can separate even the strongest of joints. I have seen some cases where the hardest of the stones like granite have been separated by roots. The process might take a long time, but the impact on the integrity of the structure is serious (as shown in this picture from Mahabalipuram, in Tamilnadu).
